Atlantic Water Gardens:

## *Eco-Blox Compression Testing Report*

June 9, 2014

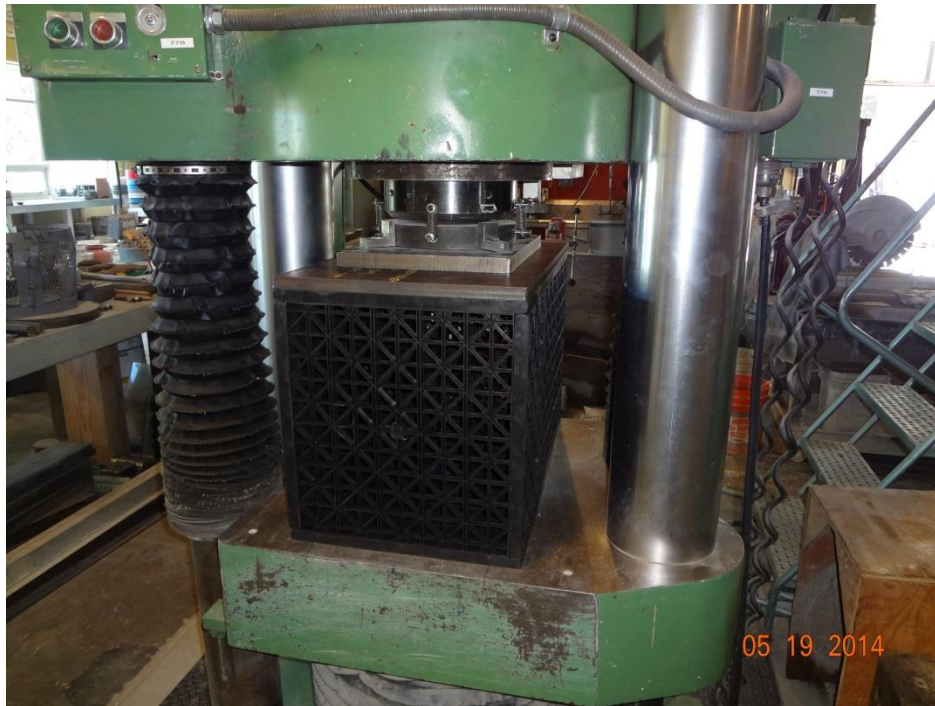
Figure 2: Test machine with steel plate on the test block.

To evenly distribute the loading across the top of the Eco-Blox, a steel plate measuring 27" x 16" x 0.75" was placed between the press and the test piece. The steel plate connected to the press cylinder measures 12" x 16" x 1" and is used to distribute the load. The test machine utilized was a Satec 600WHVL with a 600,000 lb capacity. The cross head was a Satec WHVL600 with a range of 0.050in/min to 1.000 in/min. The cross head speed and the load cell were both calibrated on May 6, 2014 and the calibration certificate is attached for reference.

The loading was applied by the top platen movement and controlled by lowering at a rate of 0.050" per minute, which was adopted from the ASTM D695-10, which is the standard test method for compressive properties of ridged plastics. A computer readout was given and the raw data of load, displacement, and time was supplied for reference as well. Pictures and video were taken during the testing to show the process and results.

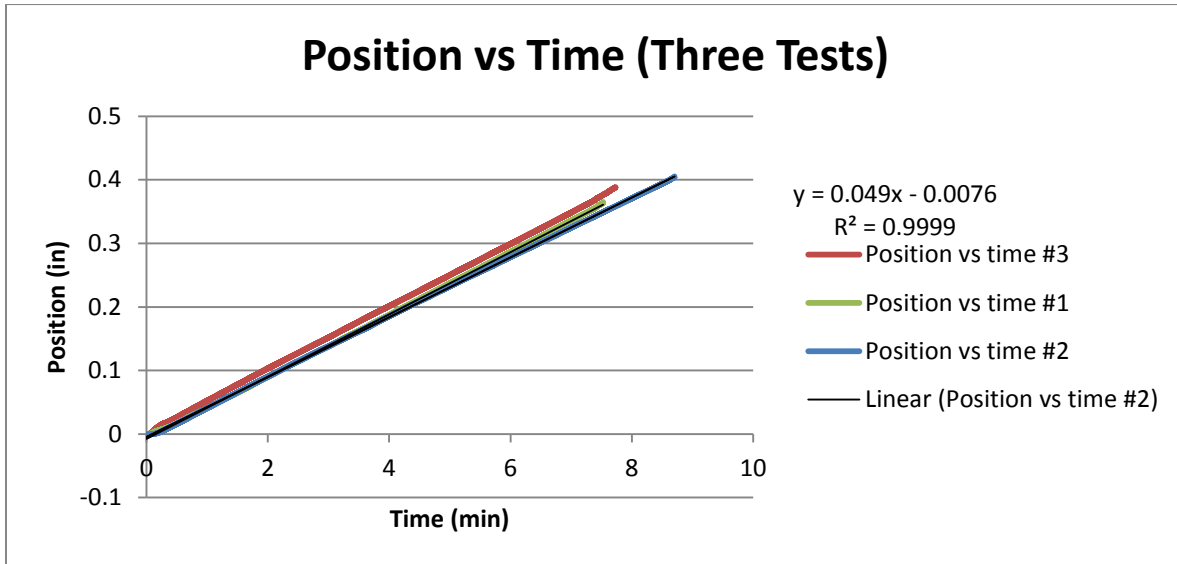
Figure 7: Position vs Time graph showing the consistency of the cross head speed across the three tests.

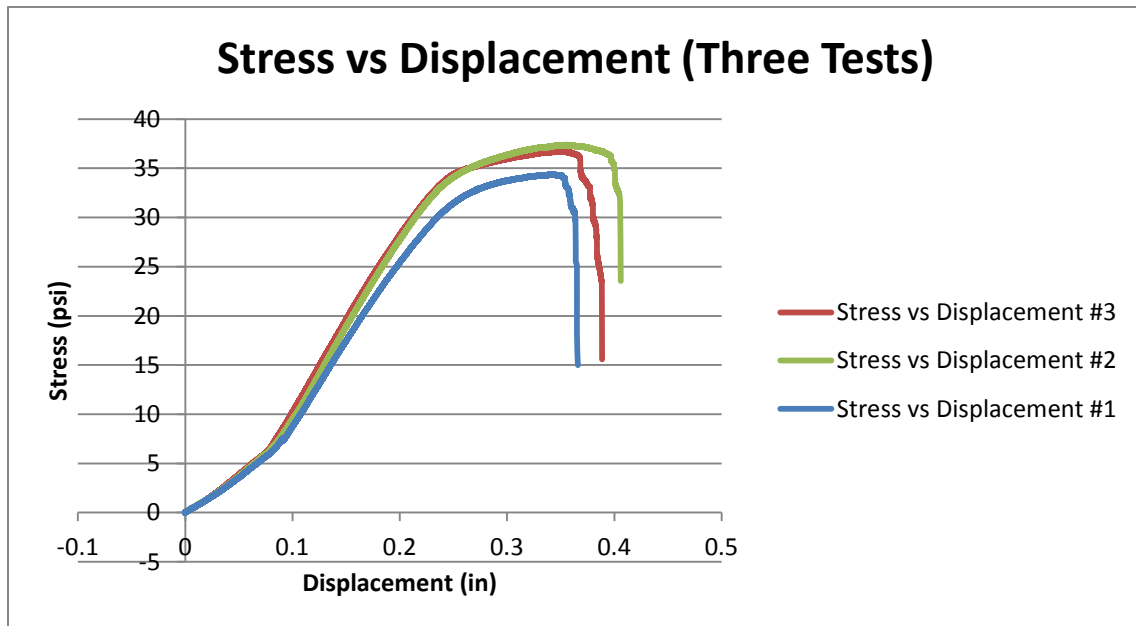
Figure 8: Stress vs Displacement graph showing the consistency of the three test matrix blocks.

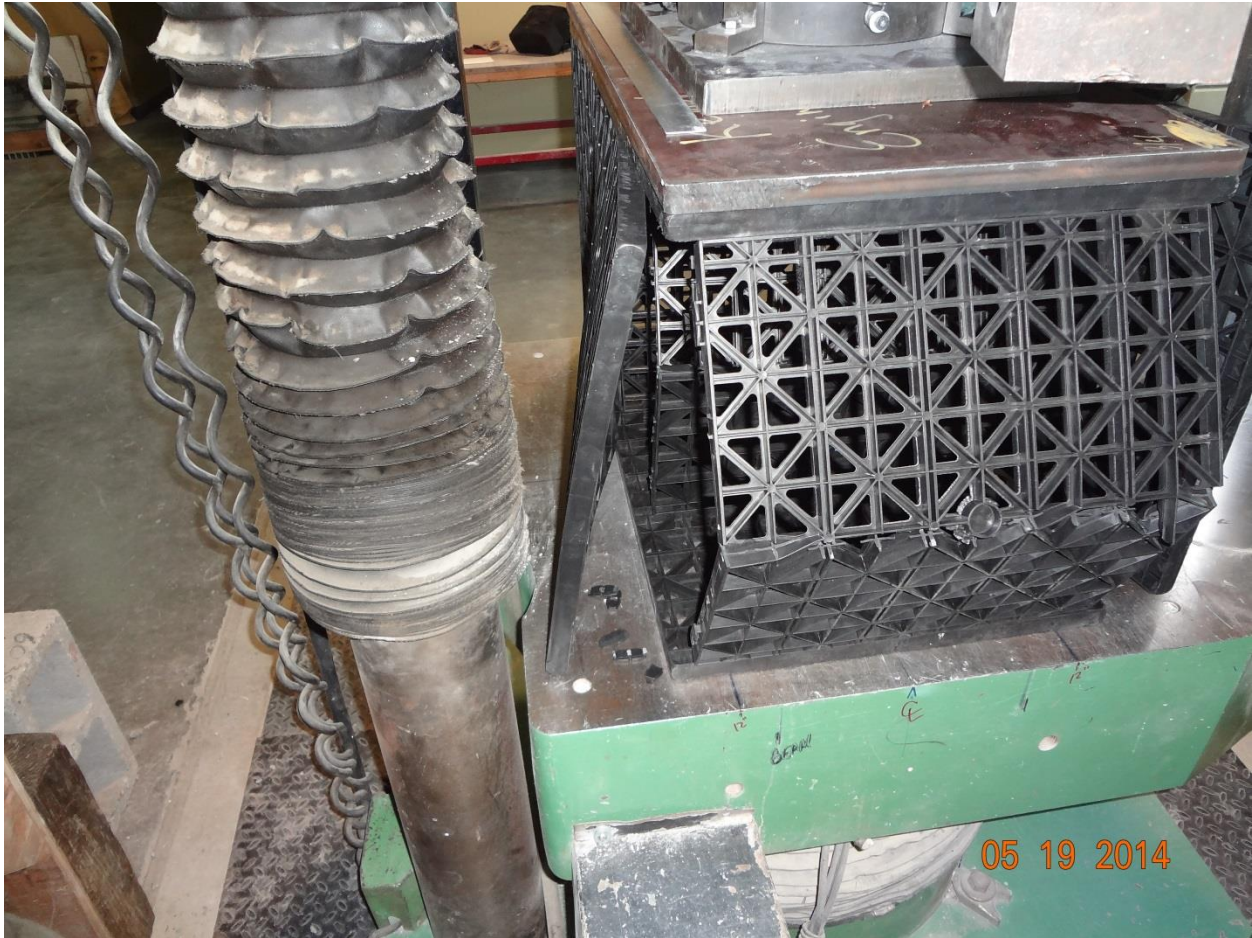
Figure 10: Second test block failure from the back side

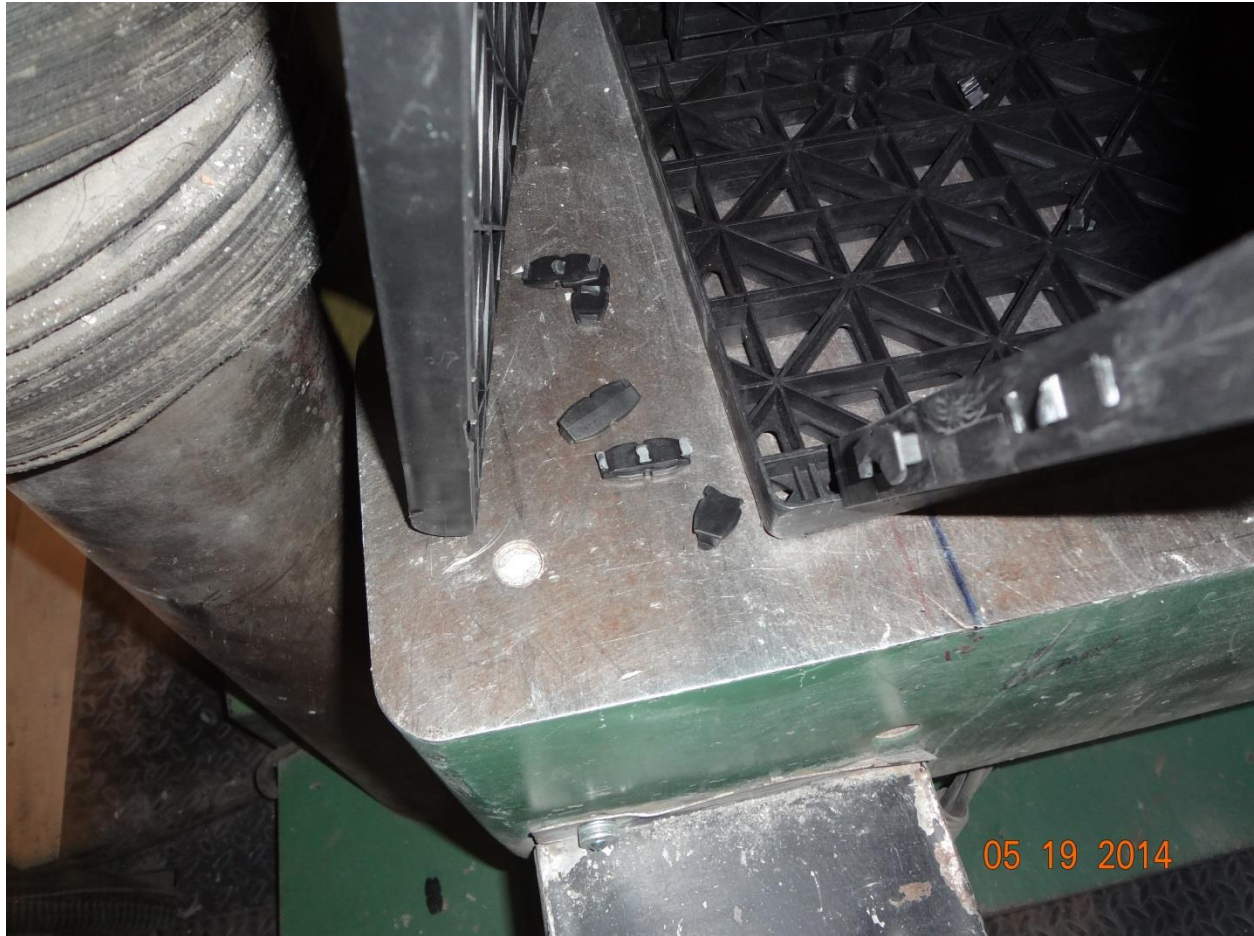
Figure 11: Broken Tabs from second test block

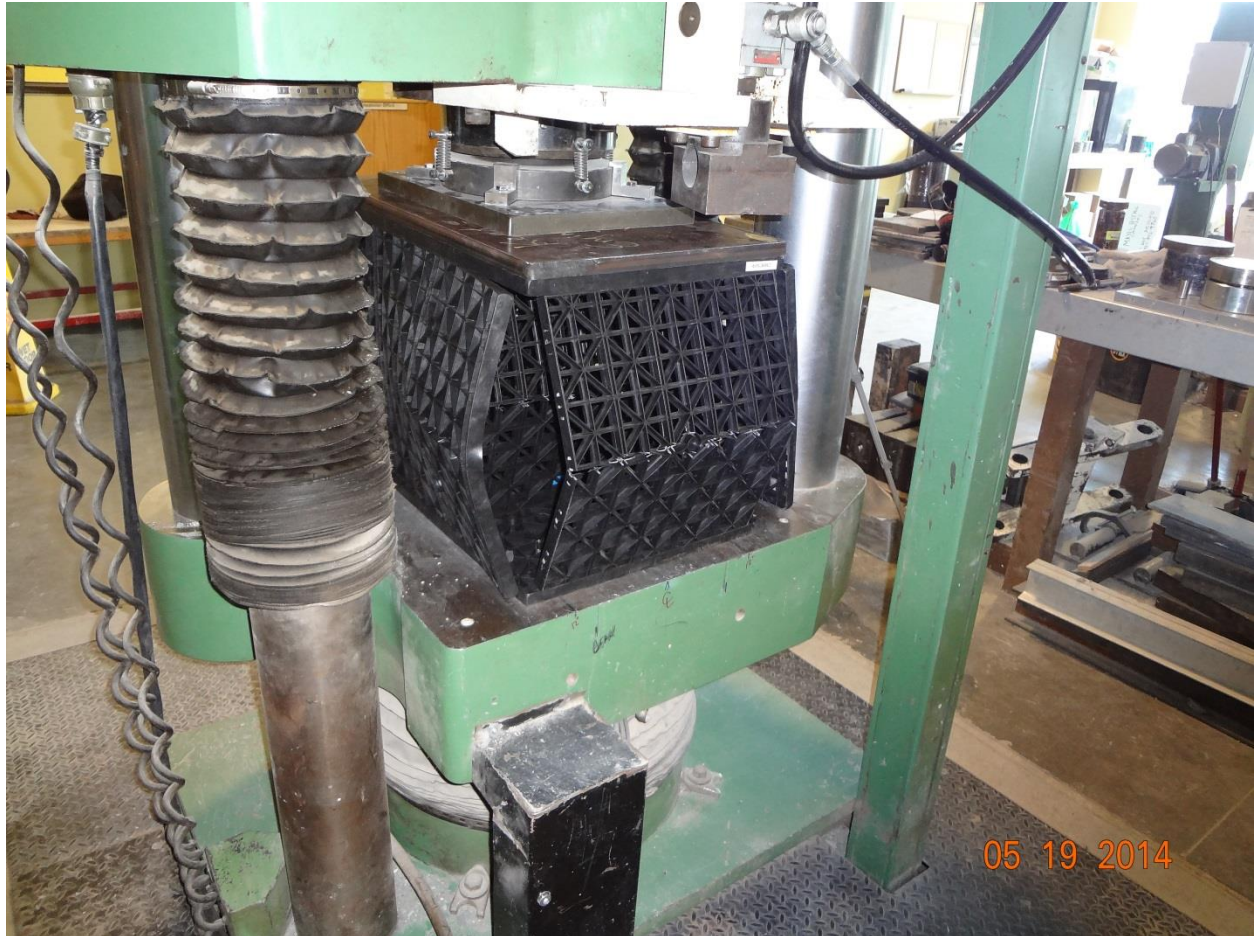
Figure 12: Third test block failure from backside

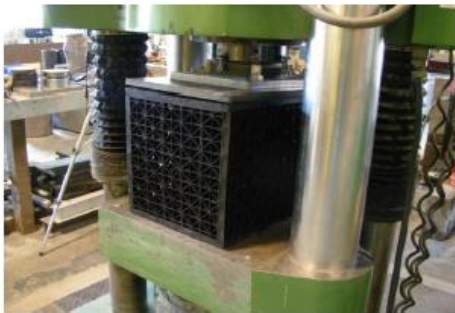
Ecology Block 6530B after Failure

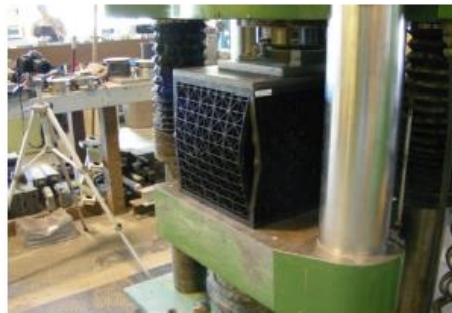
Ecology Block 6530C @ Failure

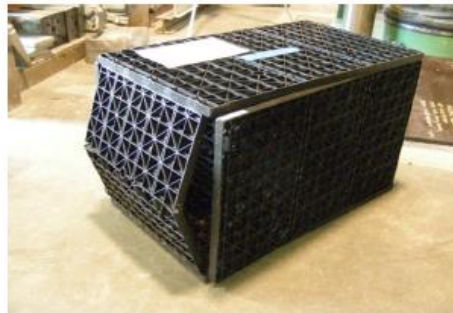
Ecology Block 6530C after Failure
